CONDITIONAL USE PERMIT APPLICATION

WETLAND DELINEATION REPORT

Germantown Lot 2

Creek View Lane & Merkel Drive

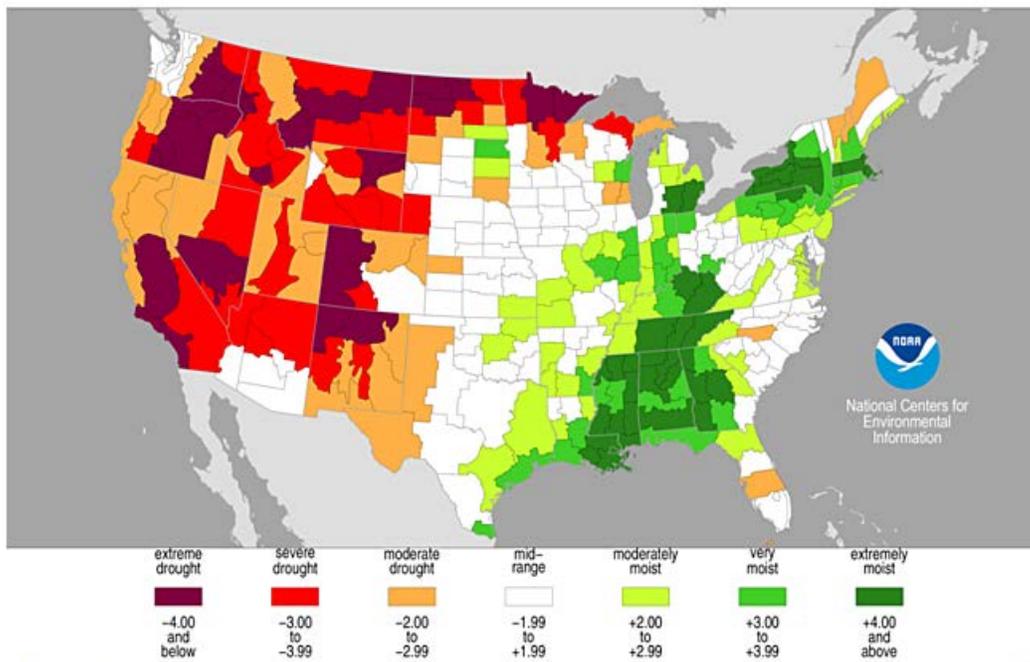
Palmer Hydrological Drought Index
October, 2021

Weather records were consulted from the Germantown Wastewater Utility weather station to determine if precipitation levels were normal for the three months prior to the site visit. The antecedent hydrologic condition analysis for the site revealed that climatic conditions near the site were normal at the time of the site visit (**Table 1**). Drier than normal conditions means that hydrologic indicators may be absent from the wetland sample points and the data must be interpreted accordingly. Wetter than normal conditions must be accounted for when interpreting the data because saturation or the water table may be higher than it is during normal conditions, giving false positives for hydrological indicators.

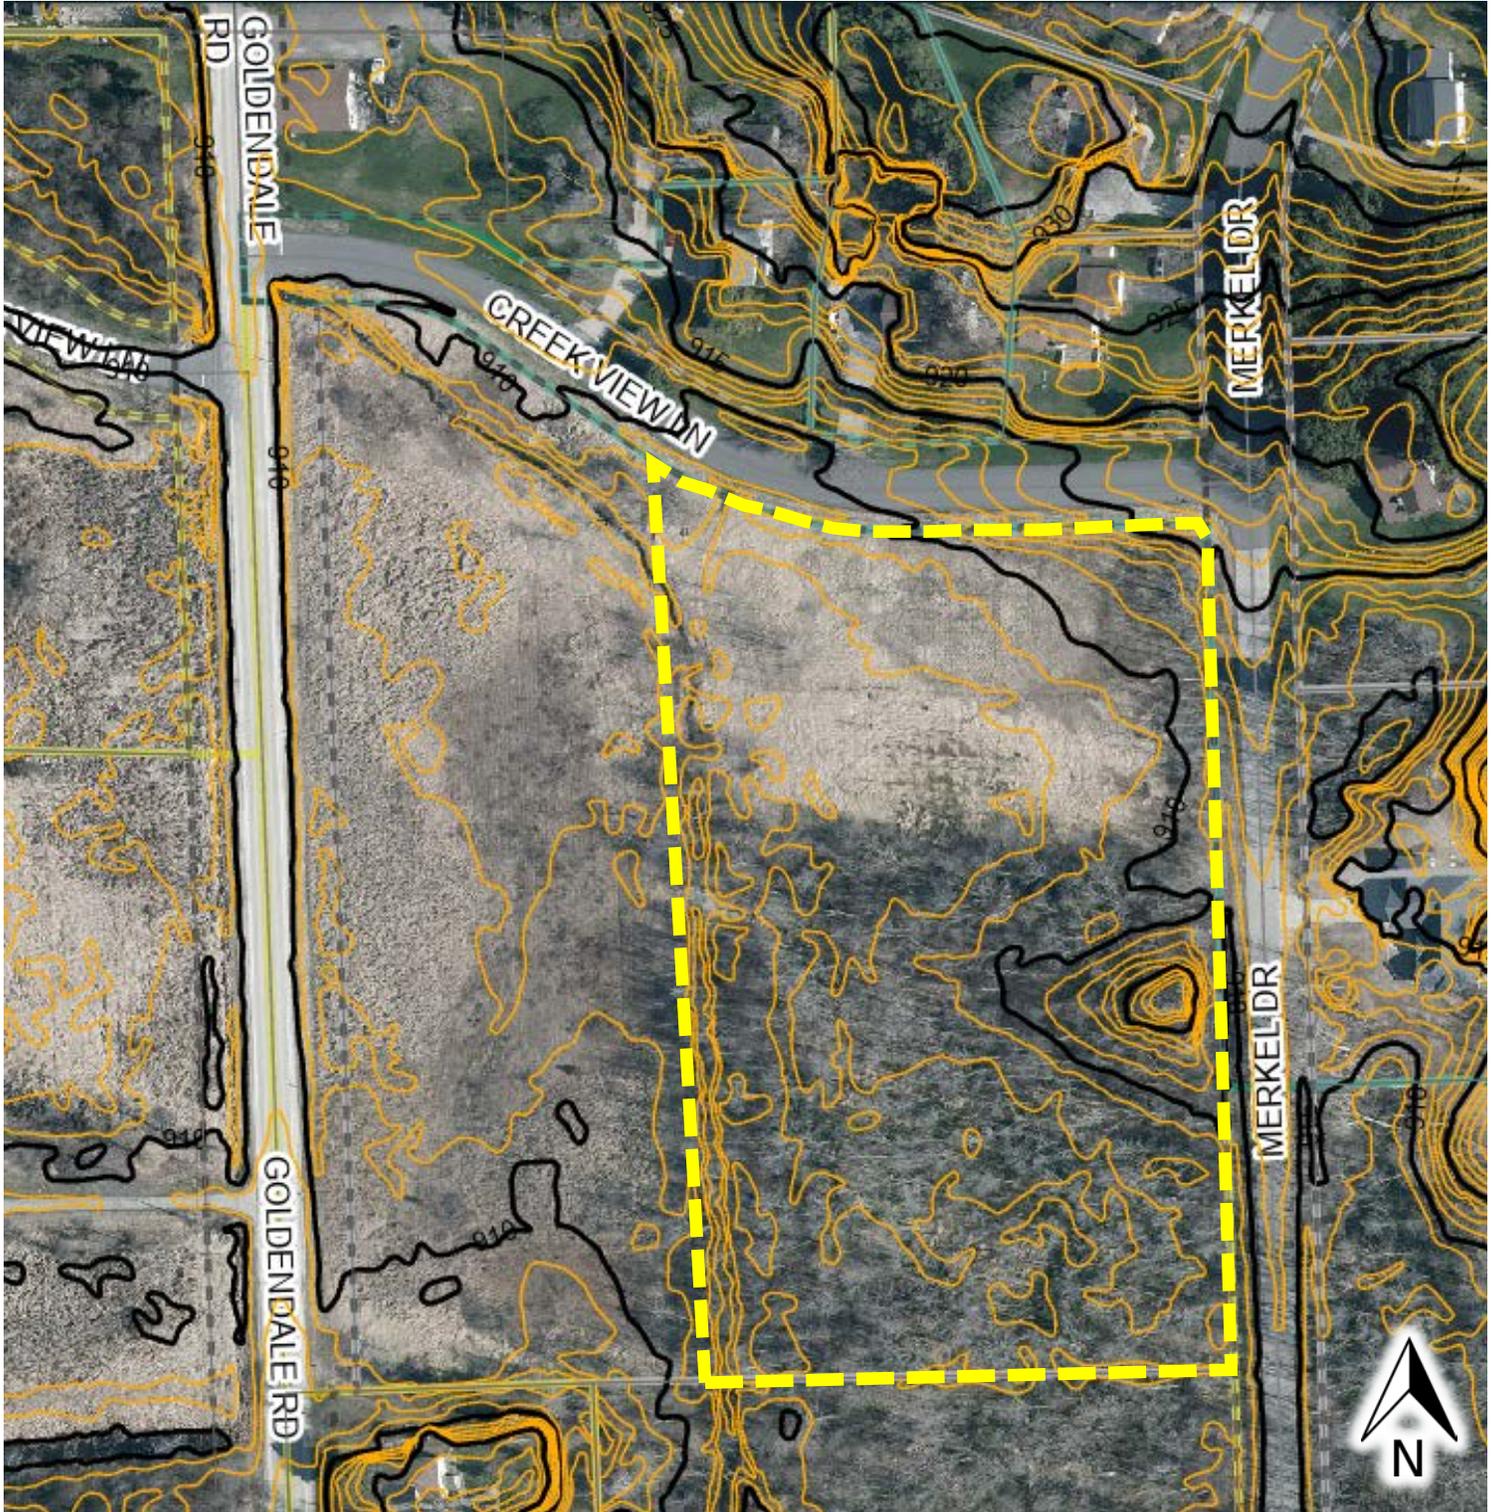
FIGURE 2. TOPOGRAPHIC MAP

The topographic map (**FIGURE 2**) shows that most of the site is relatively flat except for the northeast corner of the site. The site slopes down from the intersection of Merkel Dr. and Creek View Lane, dropping about 6 feet before it flattens out where the wetland begins. In addition, a steeply sloped fill pile is located in the middle of the east side of the parcel off Merkel Drive. Elevations within the site range from 918 feet above Mean Sea Level at the highest point on top of the fill pile and 907 at the lowest along Goldendale Creek, which flows from south to north roughly through the middle of the property.

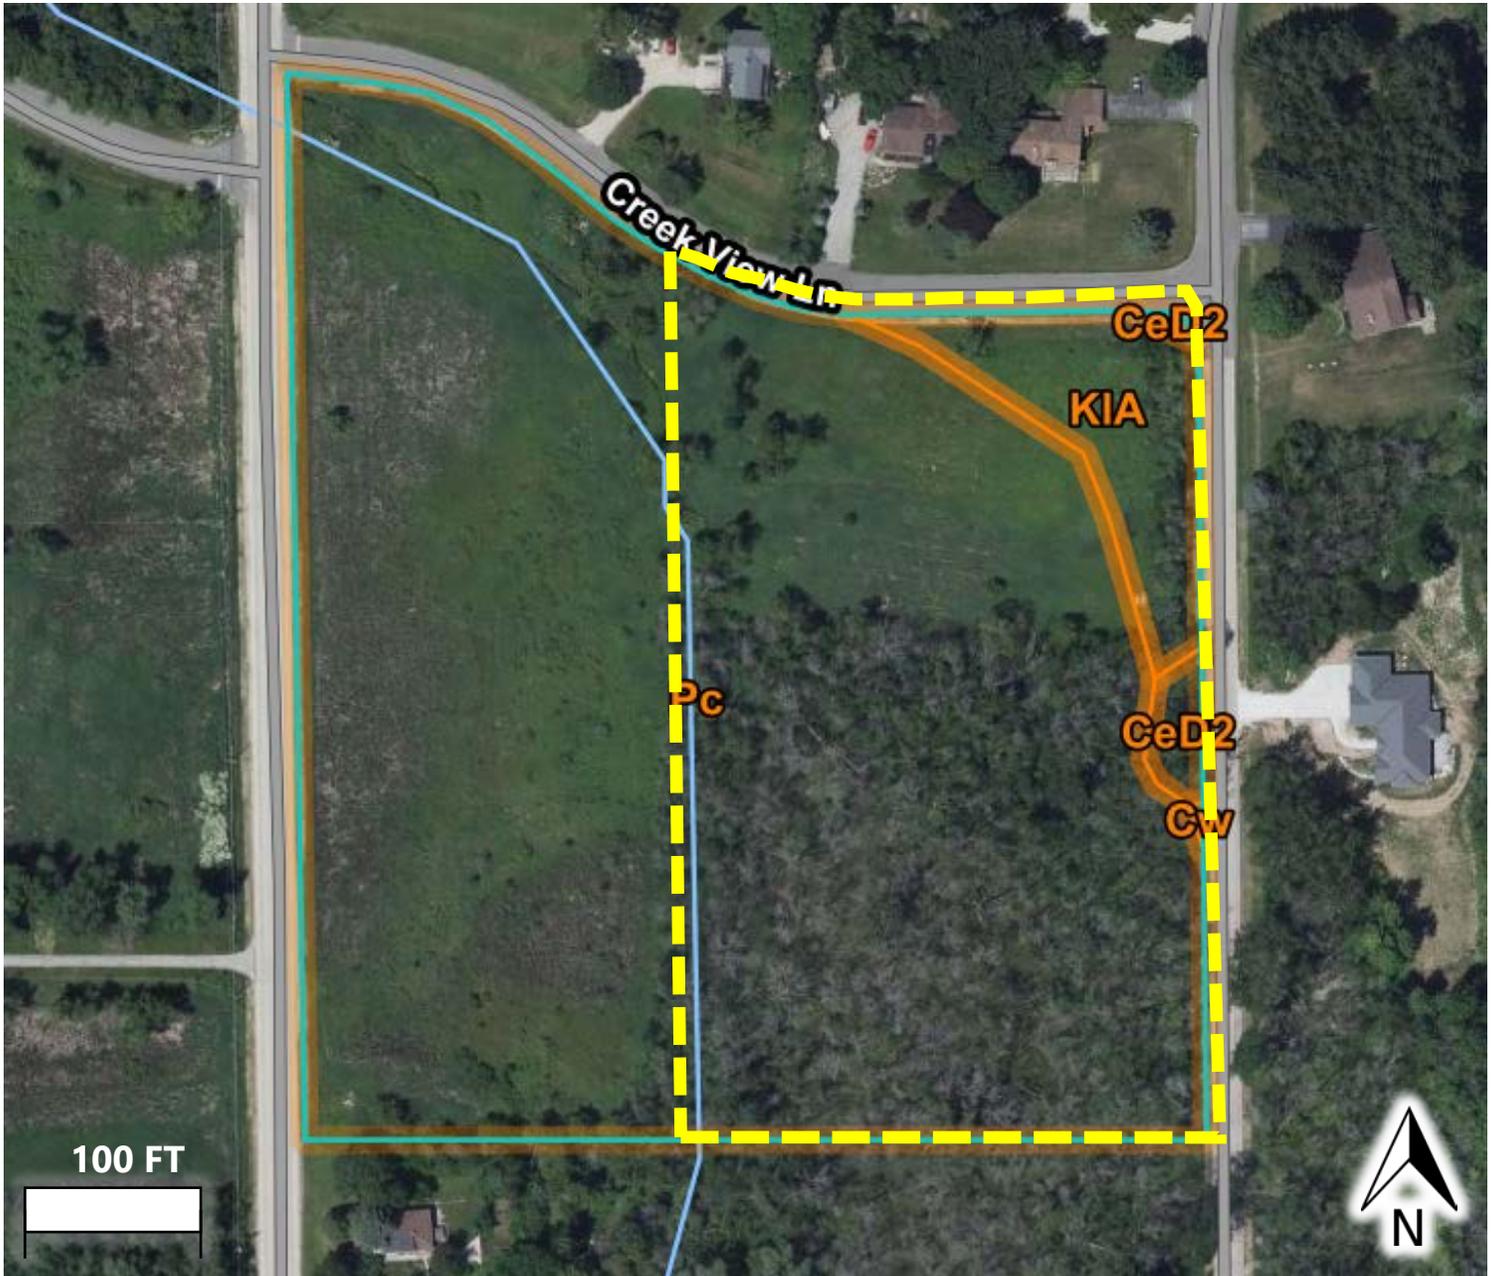
FIGURE 3. SOIL SURVEY MAP

There are five soil types on the site. The soil survey map shows a large area of Palms mucky peat (Pc) throughout most of the site and a small area of Colwood silt loam (Cw) along the east boundary, which are both hydric (**FIGURE 3**). Kendall silt loam (KIA) is predominantly non-hydric but may contain hydric inclusions in depressions. All soil types occurring on the property are listed in **Table 2**.

Map Unit Symbol	Map Unit Name
CeC2	Casco loam, 6-12%, eroded
CeD2	Casco loam, 12-20%, eroded
Cw	Colwood silt loam, 0-2%
KIA	Kendall silt loam, 1-3%
Pc	Palms mucky peat, 0-2%

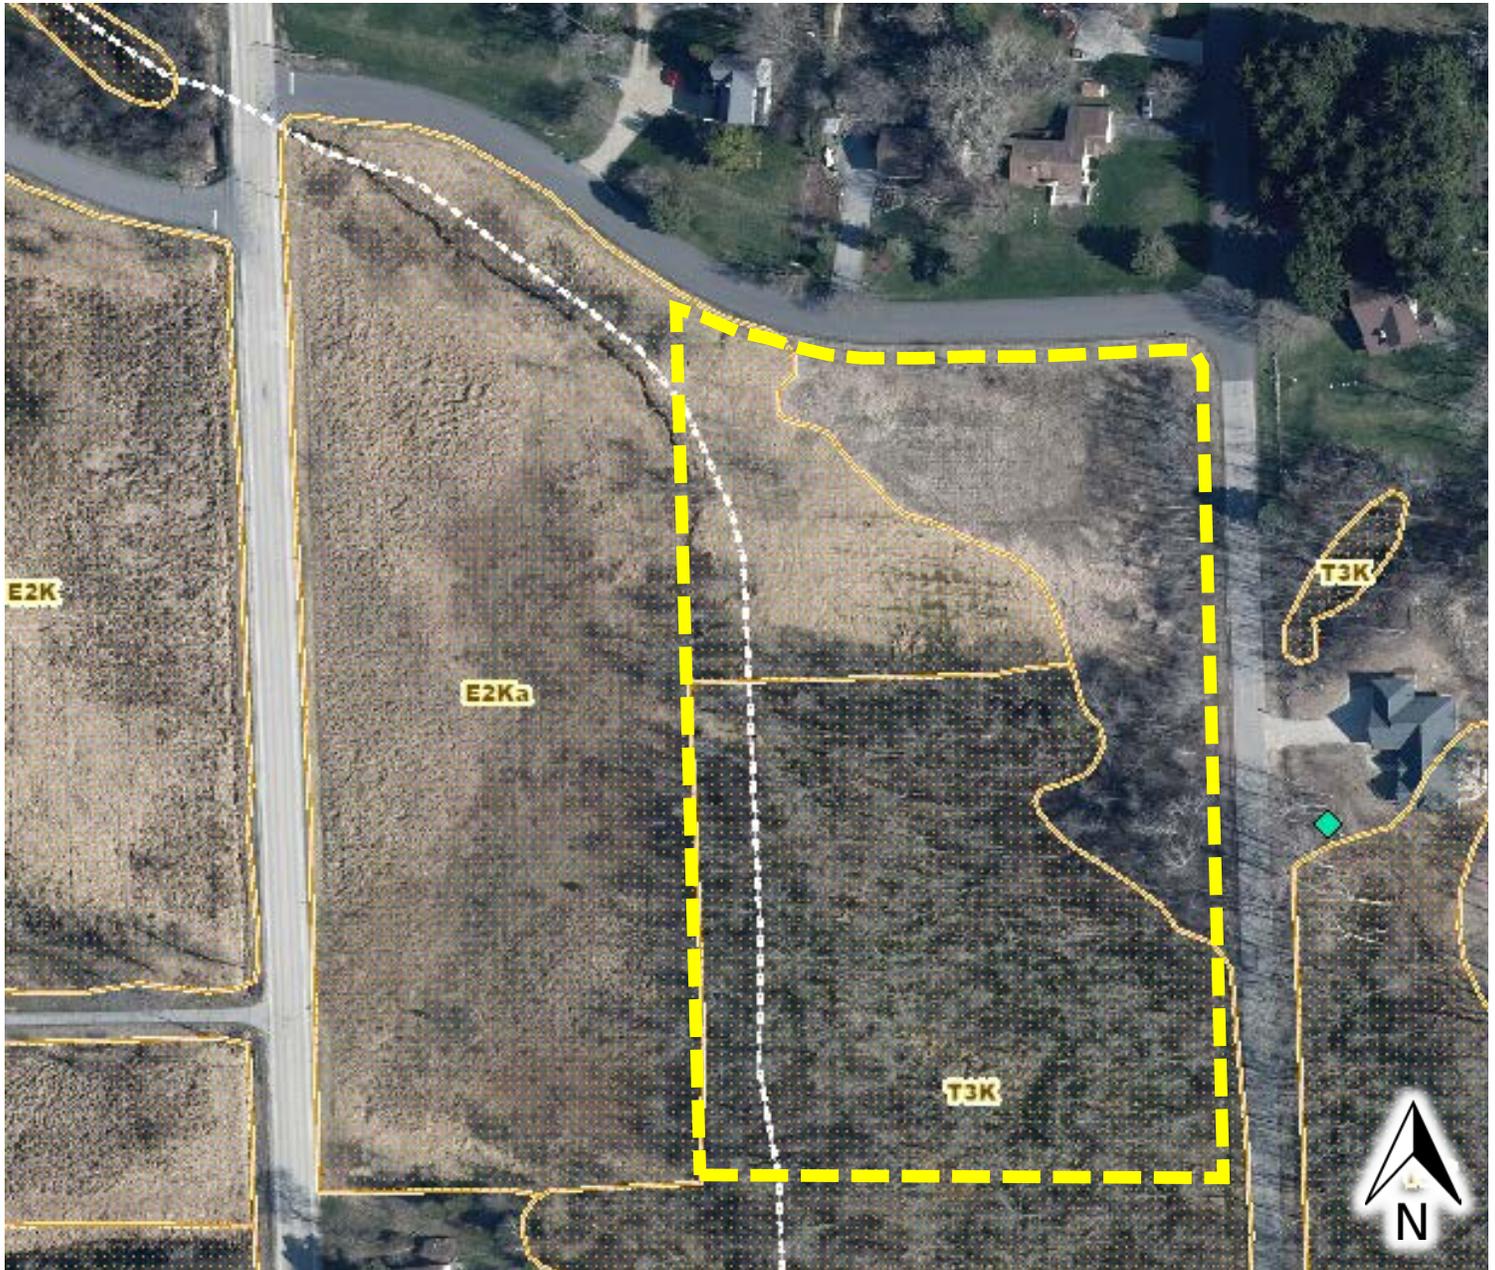
FIGURE 4. WWI MAP

The Wisconsin Wetland Inventory identifies two wetlands occupying most of the site. An E2Ka, emergent wetland, is located on the north half of site and a T3K, forested wetland, is in the southeastern corner (**FIGURE 4**).

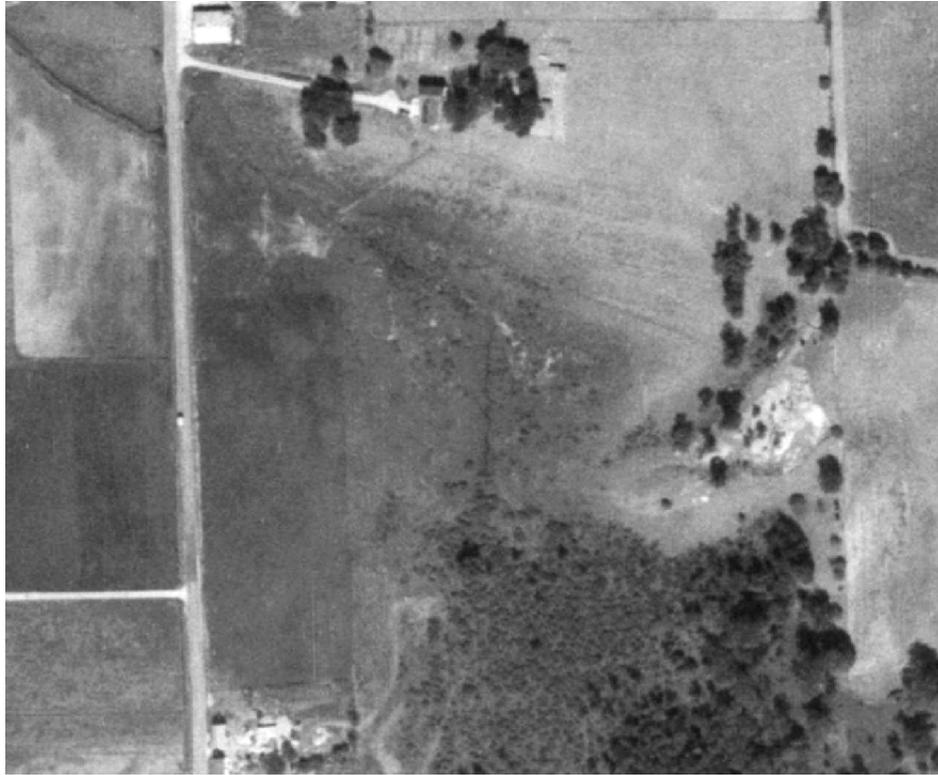
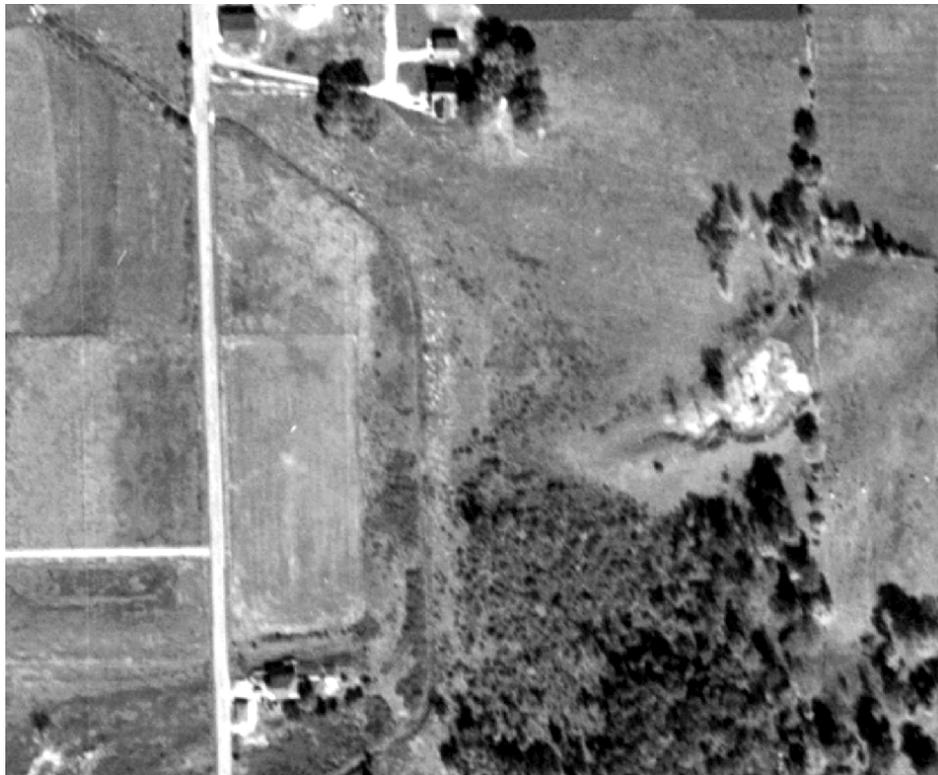
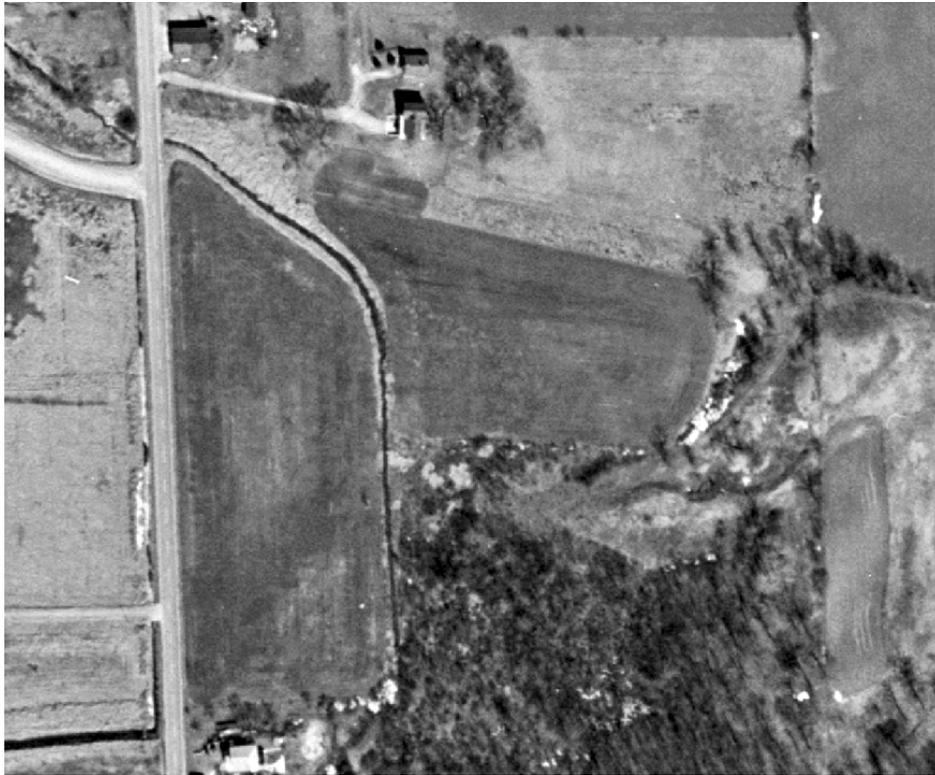
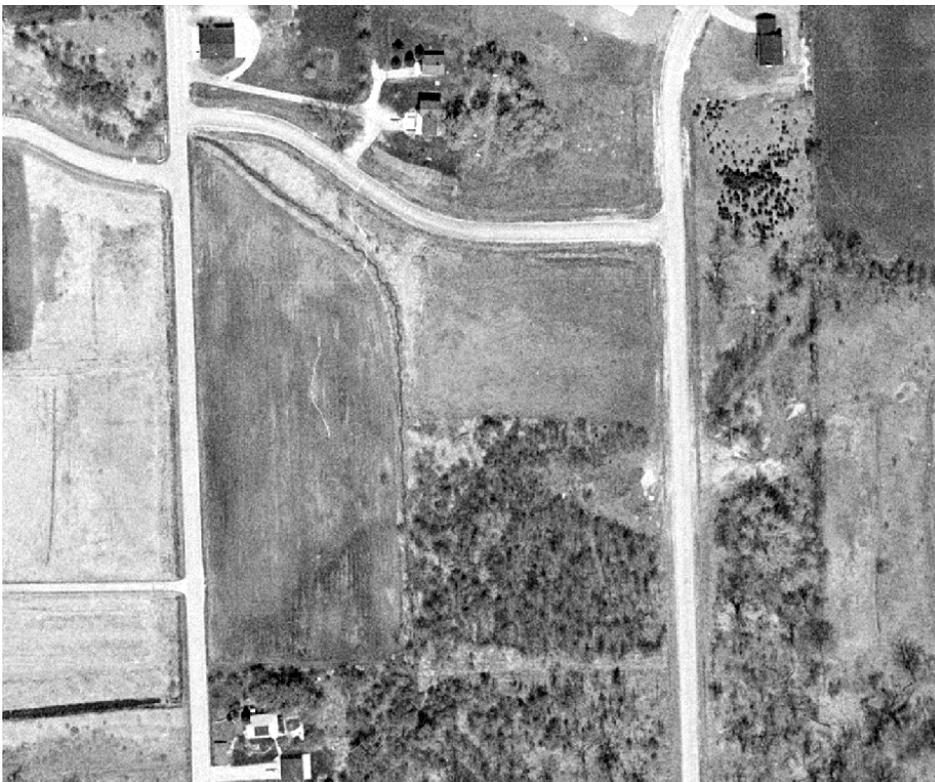
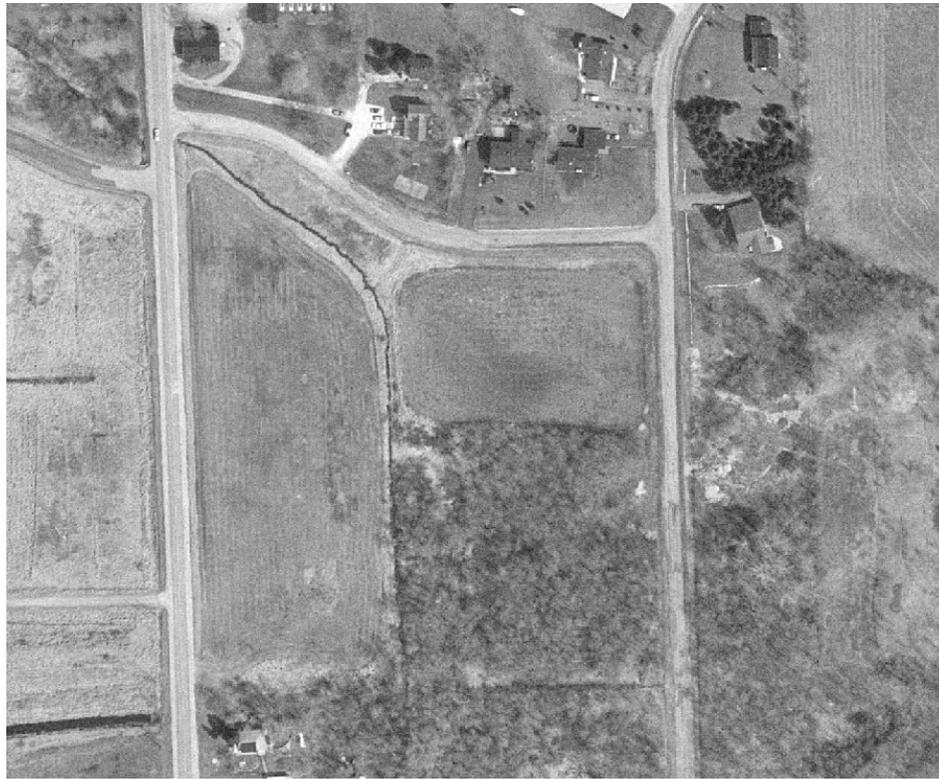
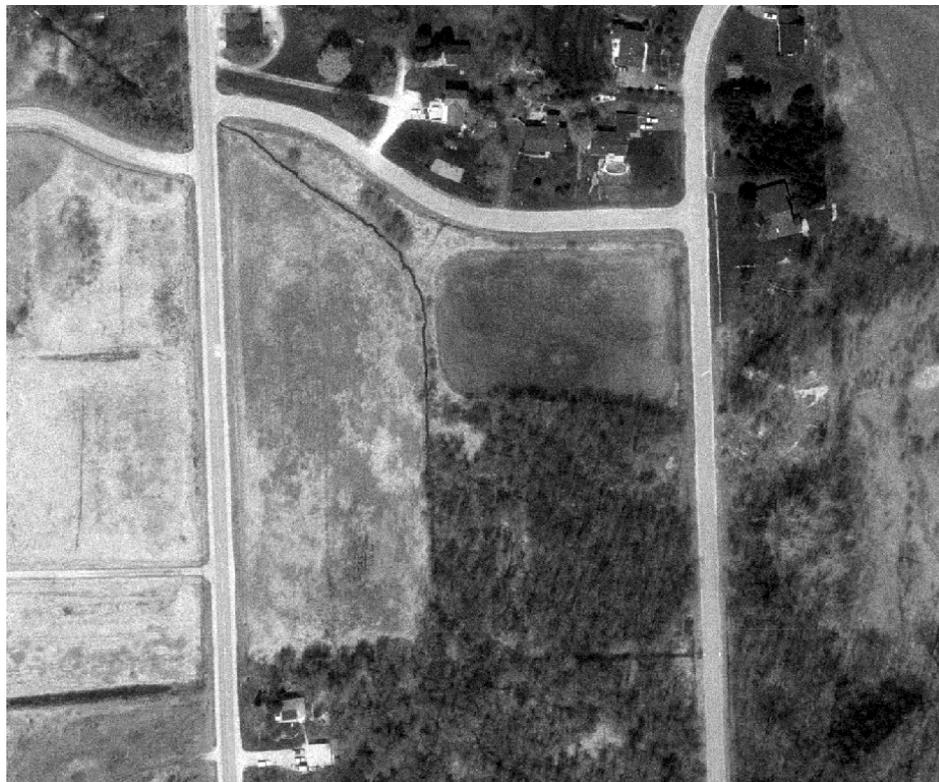
FIGURE 5. HISTORIC AERIAL PHOTOS

Historic aerial photographs show the presence of Goldendale Creek, forested wetland, and wet meadow wetland occupying most of the site since before 1941 (**FIGURE 5**). In the 1960's, Creek View Lane and Merkel Drive were constructed. A rectangular section of land in the north part of the area of interest appears to have been farmed up until the early 2000s. Farming then ceased and those areas were then allowed to fill in as disturbed wet meadow wetland and old field.

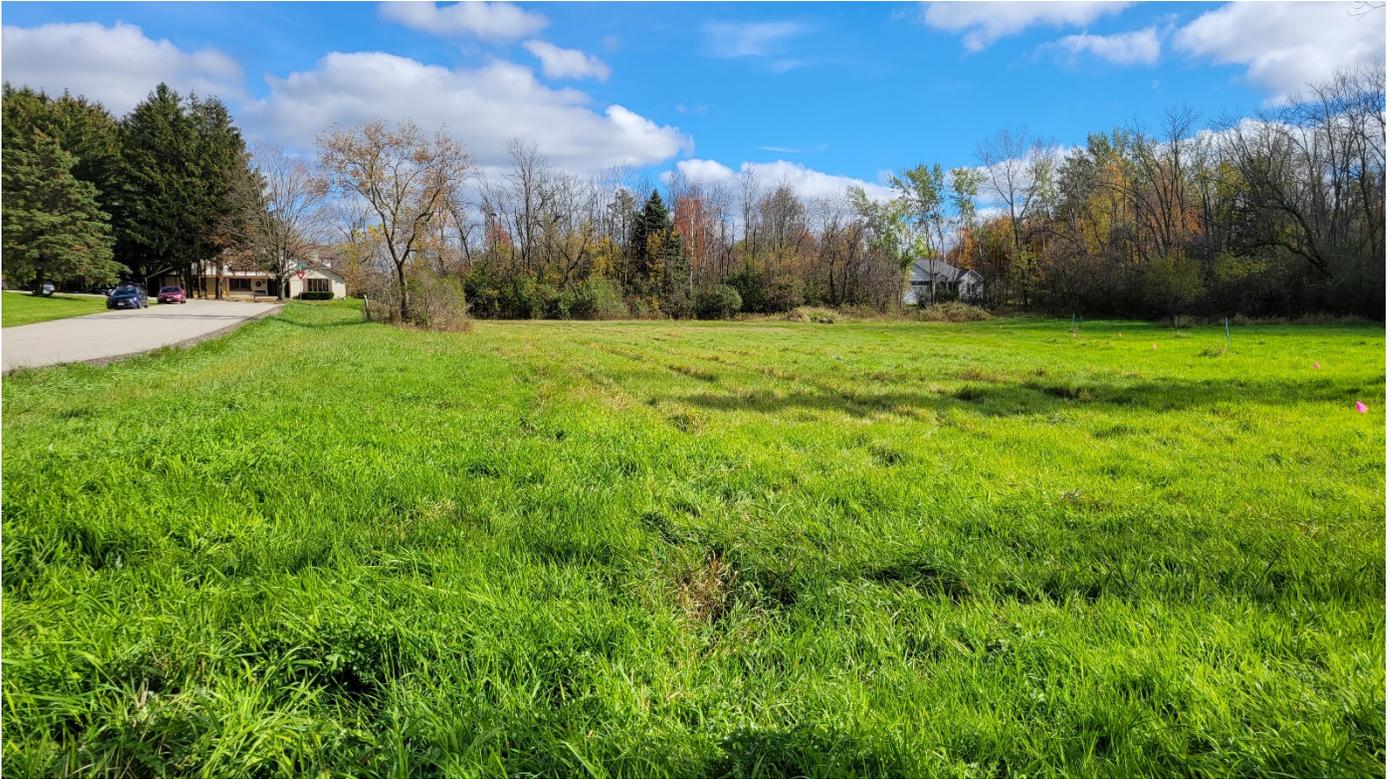
FIGURE 6. SITE PHOTOS

View of mowed wet meadow wetland (right) abutting mowed old field along the roadside (left).

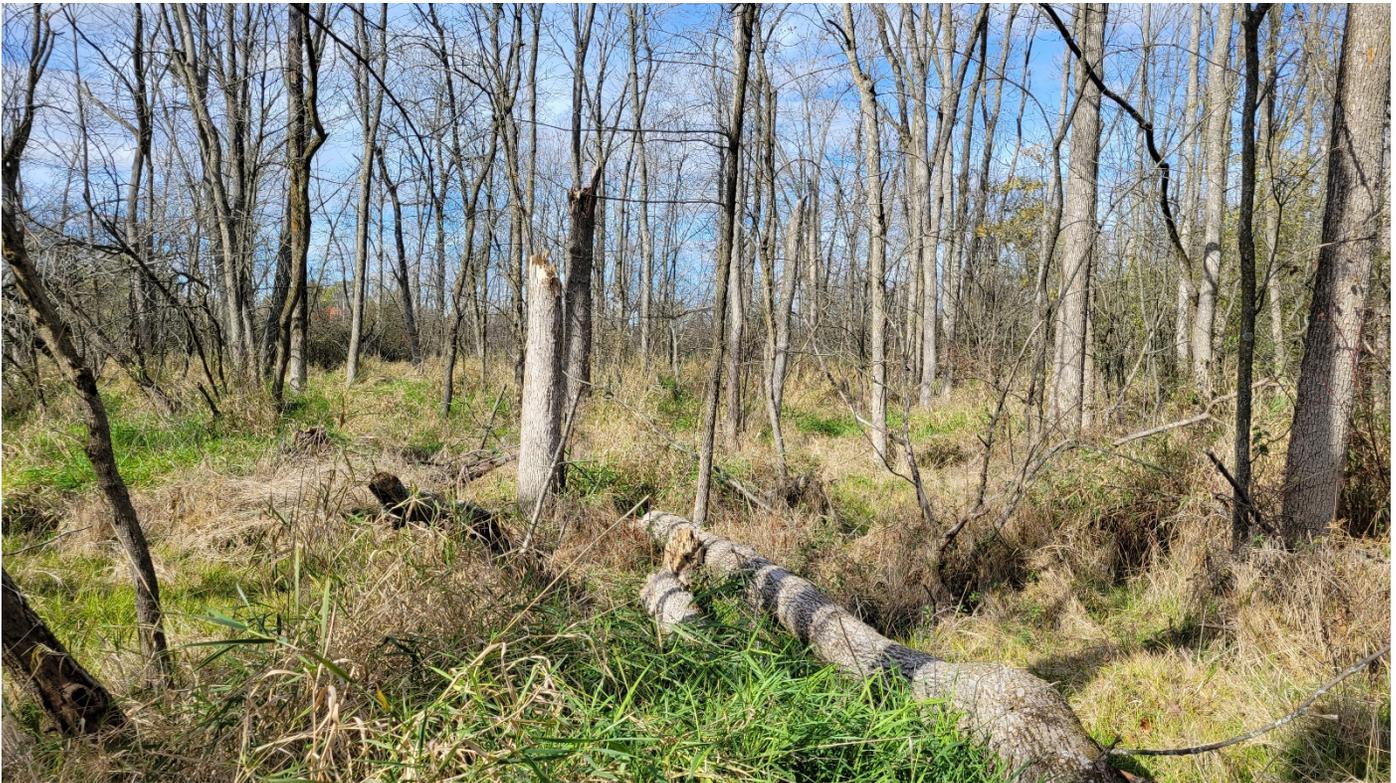
Disturbed forested/emergent wetland with 60% dead ash canopy at sample point #6.

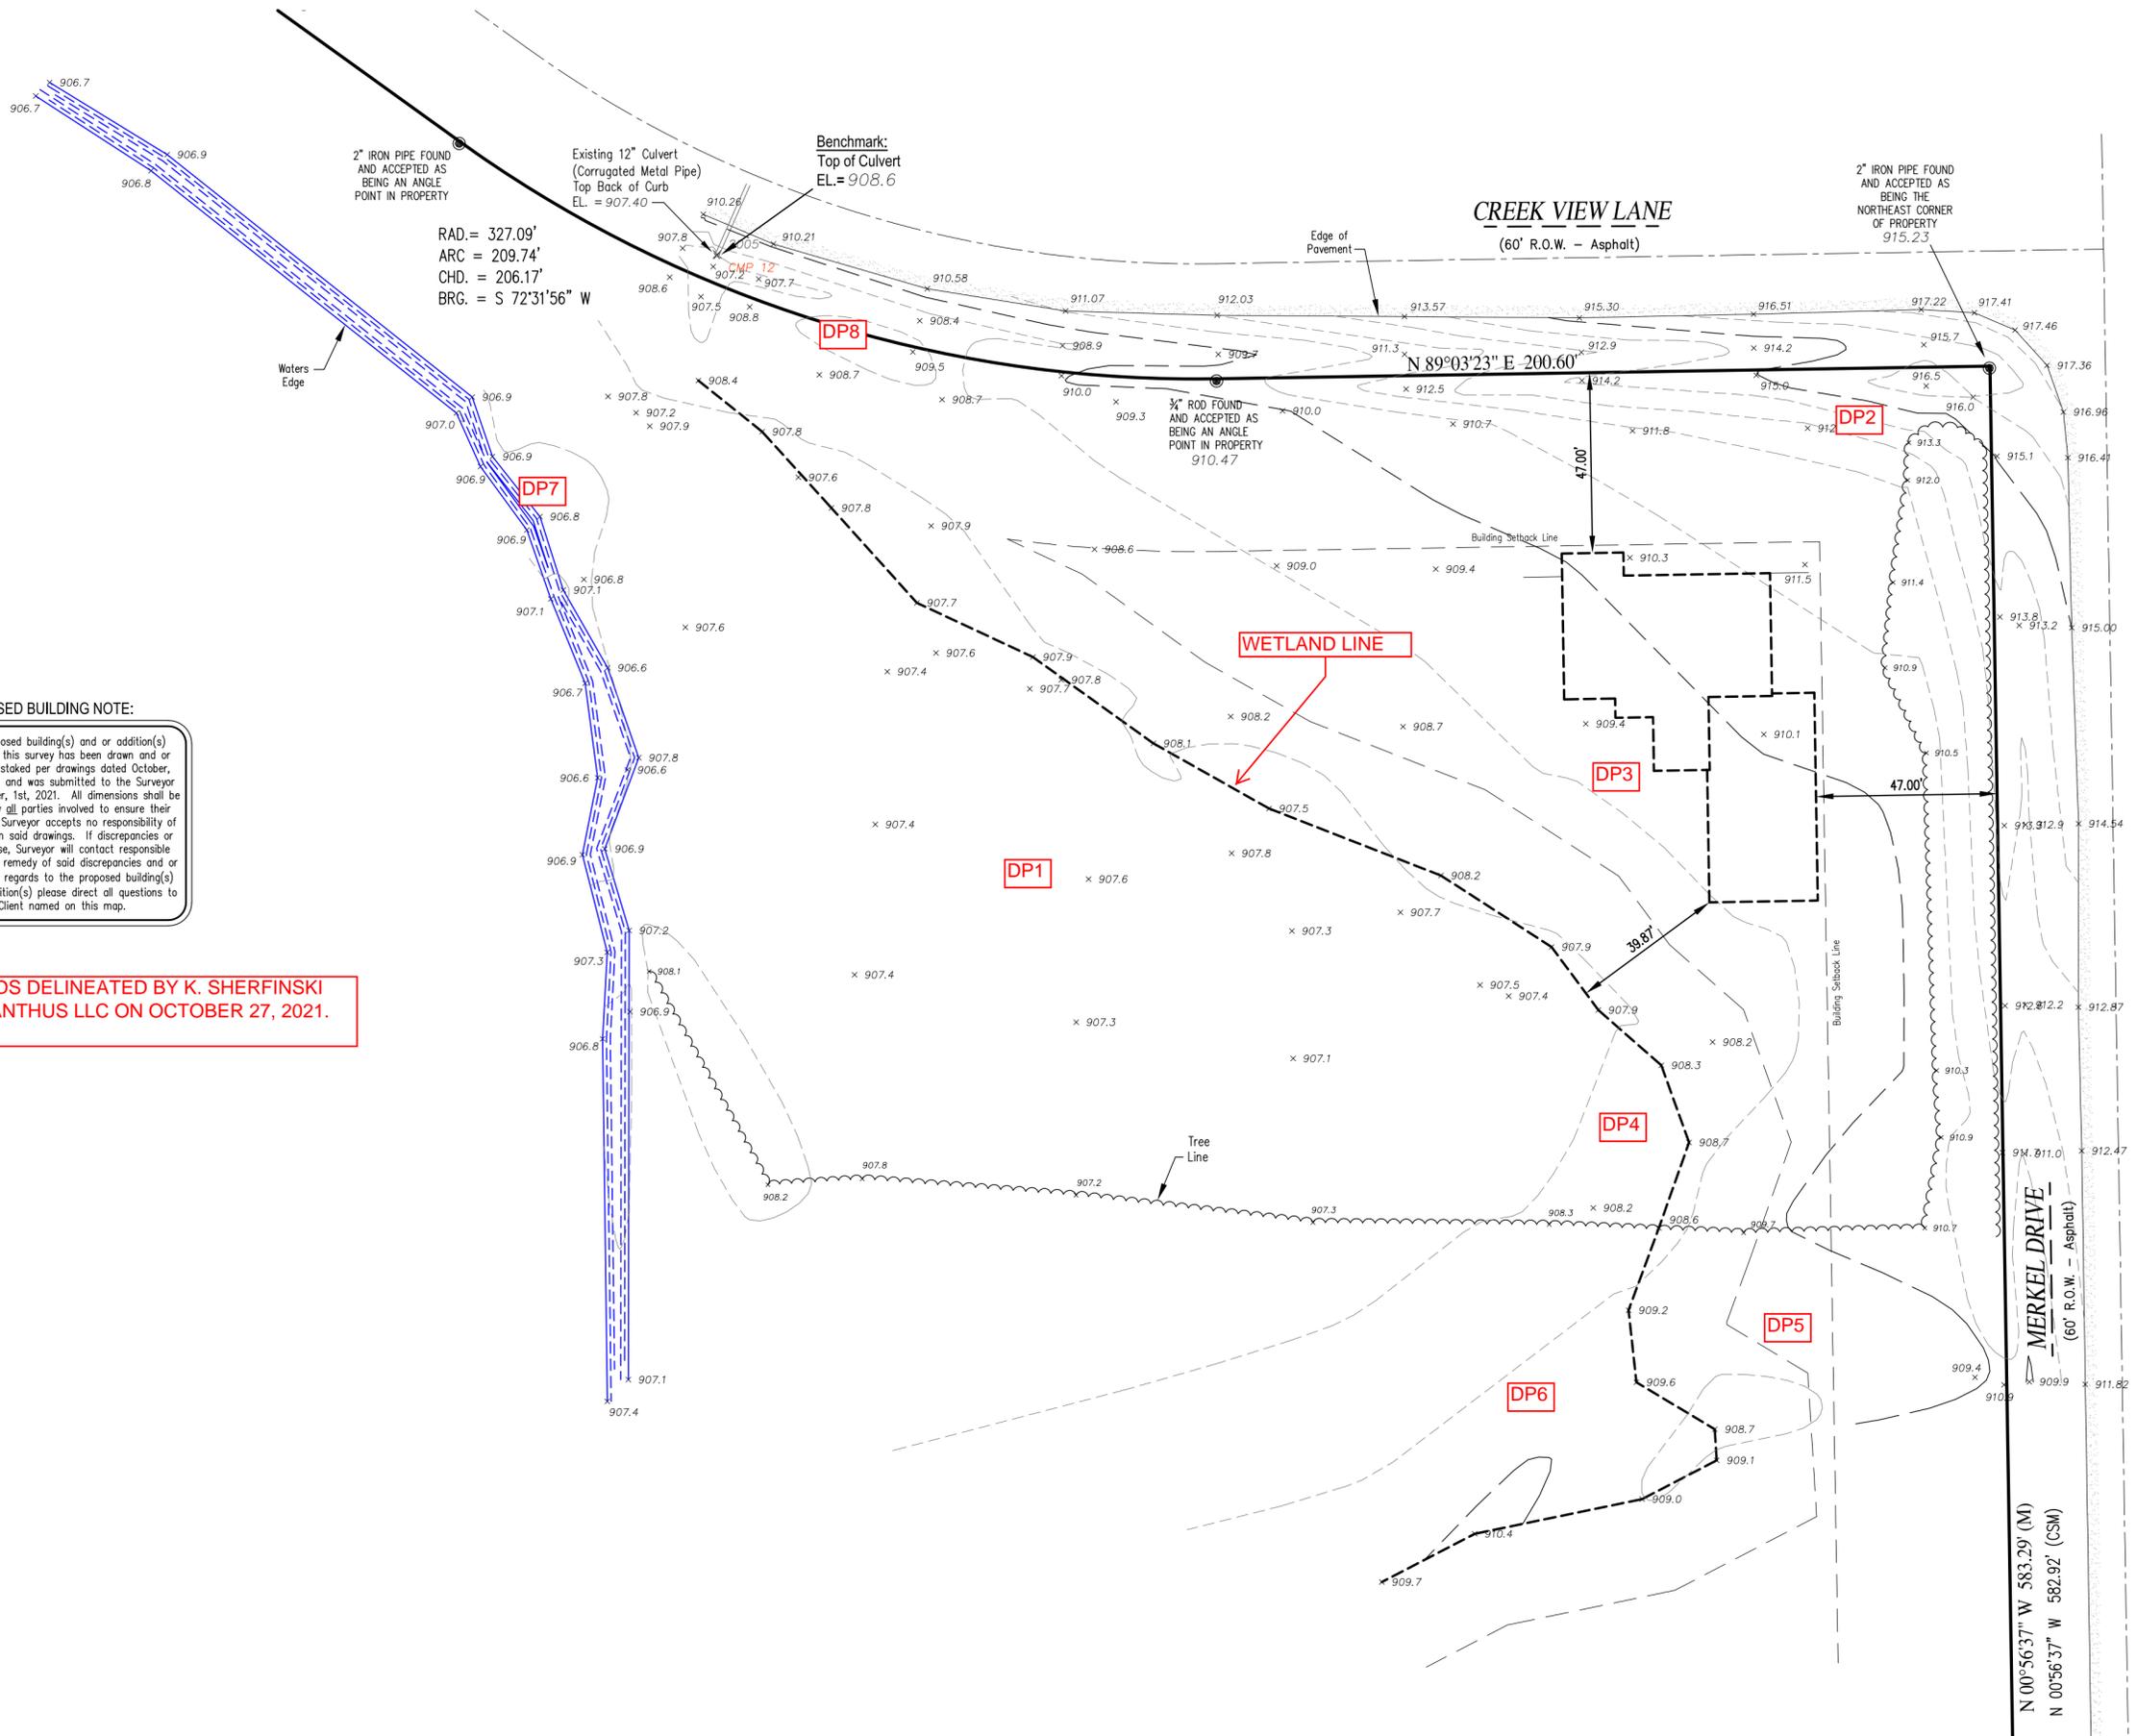
FIGURE 7. WETLAND BOUNDARY MAP

The predominant land cover for this property is disturbed forested/emergent wetland, disturbed wet meadow, and old field. The purpose of the wetland delineation was to identify existing wetlands on the property and to create a map of their boundaries. A map of the surveyed wetland boundaries is found in **FIGURE 7**.

Once the location of the wetland line is determined from the data sampling effort, the edge of the wetland is flagged in the field and then surveyed in order to produce a map of the wetland that occurs on the subject property. Representative photographs of the sample points and of each wetland area were taken during the field visit. Any ditch, stream, pond or other water body that may be considered a Water of the U.S. and thus regulated by the U.S. Army Corps of Engineers (USACE) or the Wisconsin Department of Natural Resources (WDNR) is also identified.

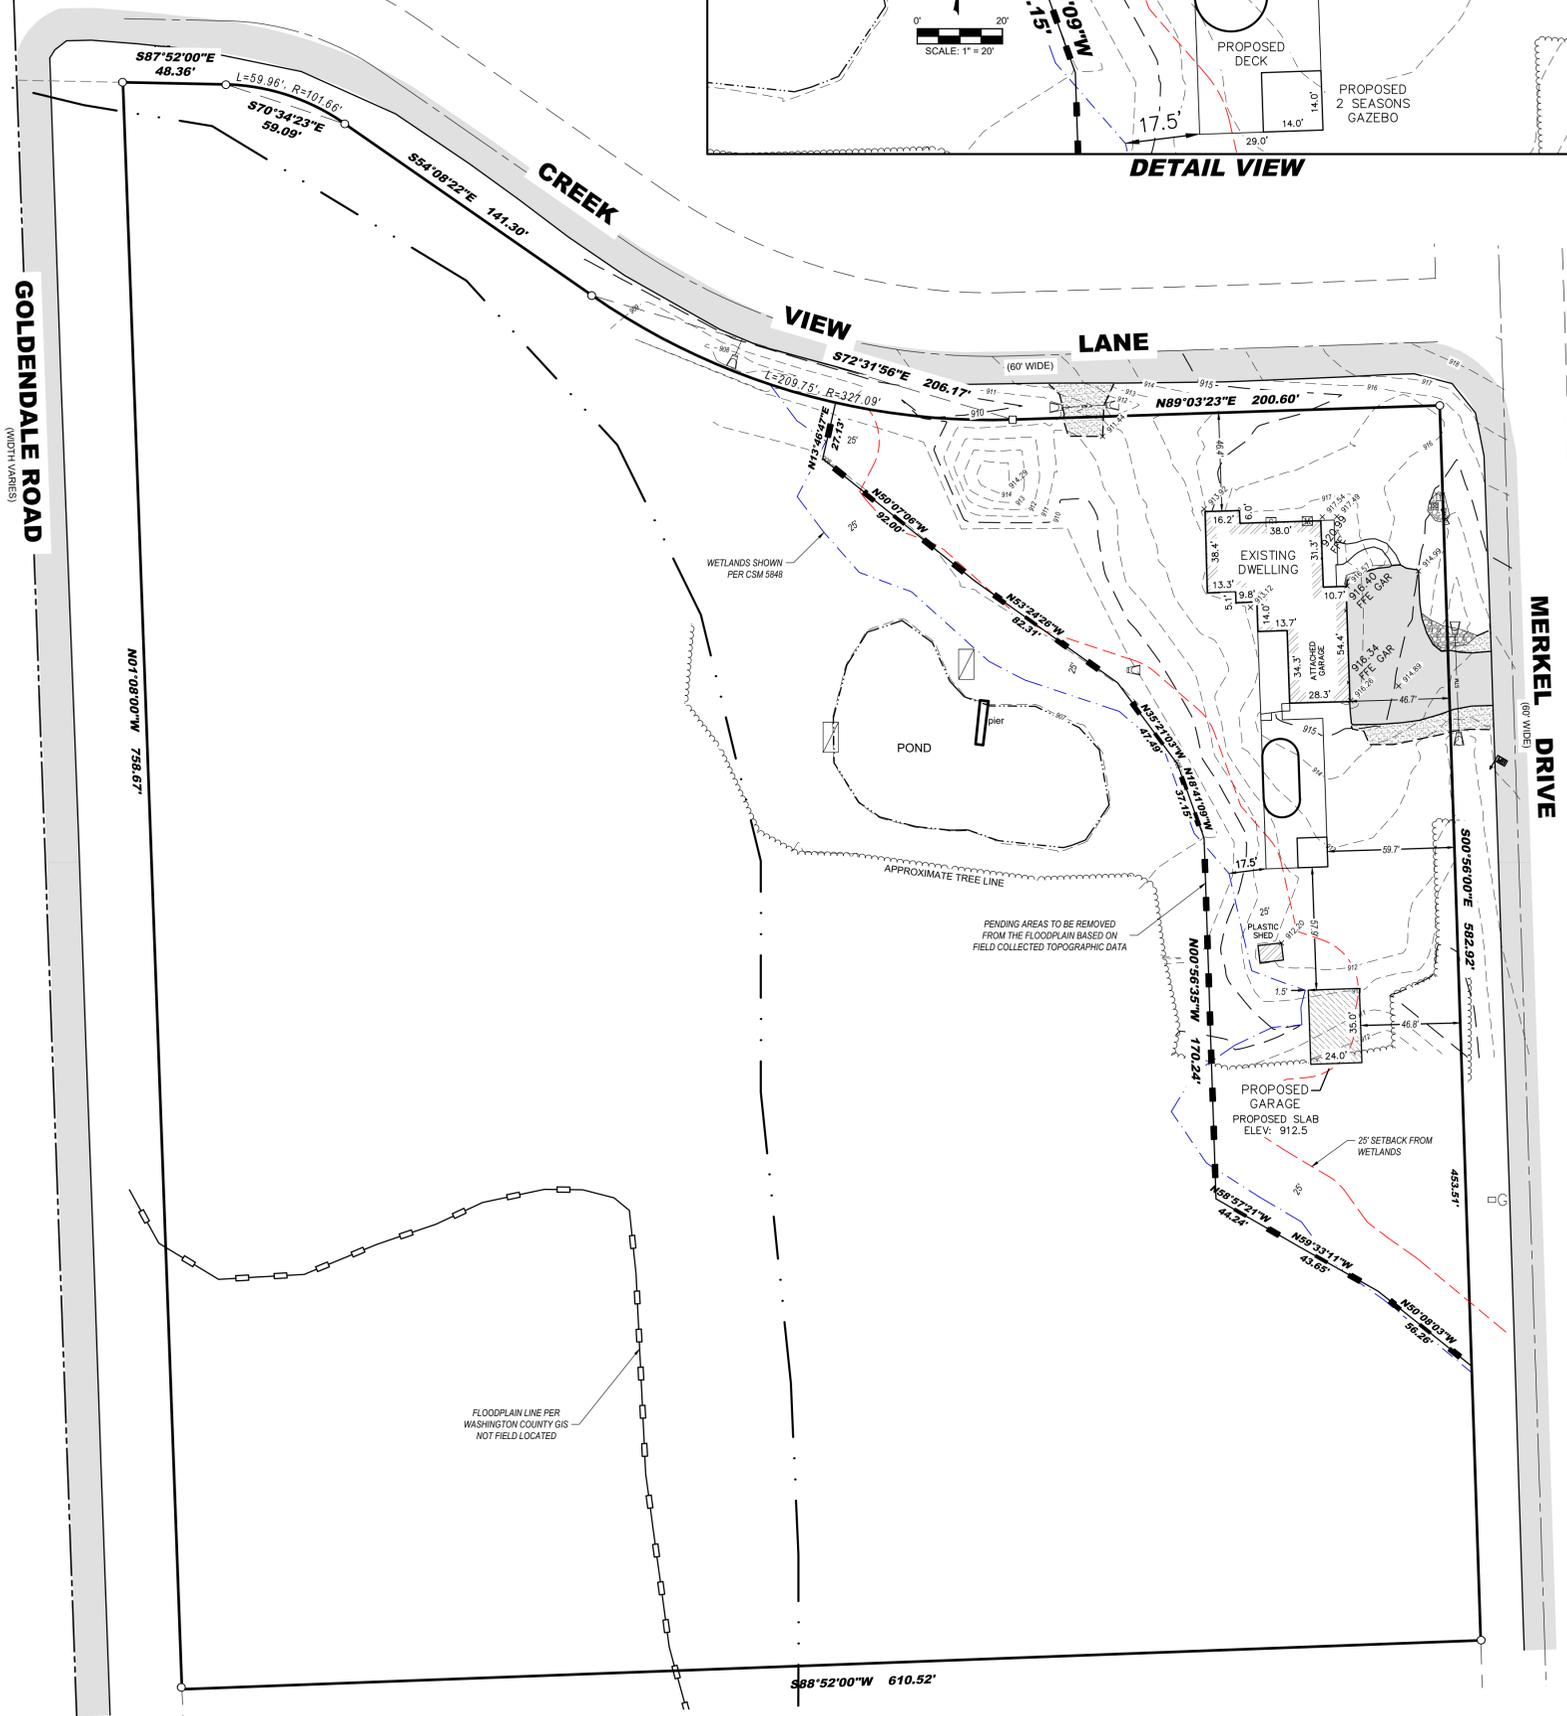
FLOODPLAIN AS SHOWN IS
PENDING FEMA APPROVAL

PENDING AREAS TO BE REMOVED
FROM THE FLOODPLAIN BASED ON
FIELD COLLECTED TOPOGRAPHIC DATA
