CONDITIONAL USE PERMIT APPLICATION

WETLAND DELINEATION REPORT

Germantown Lot 2

Creek View Lane & Merkel Drive

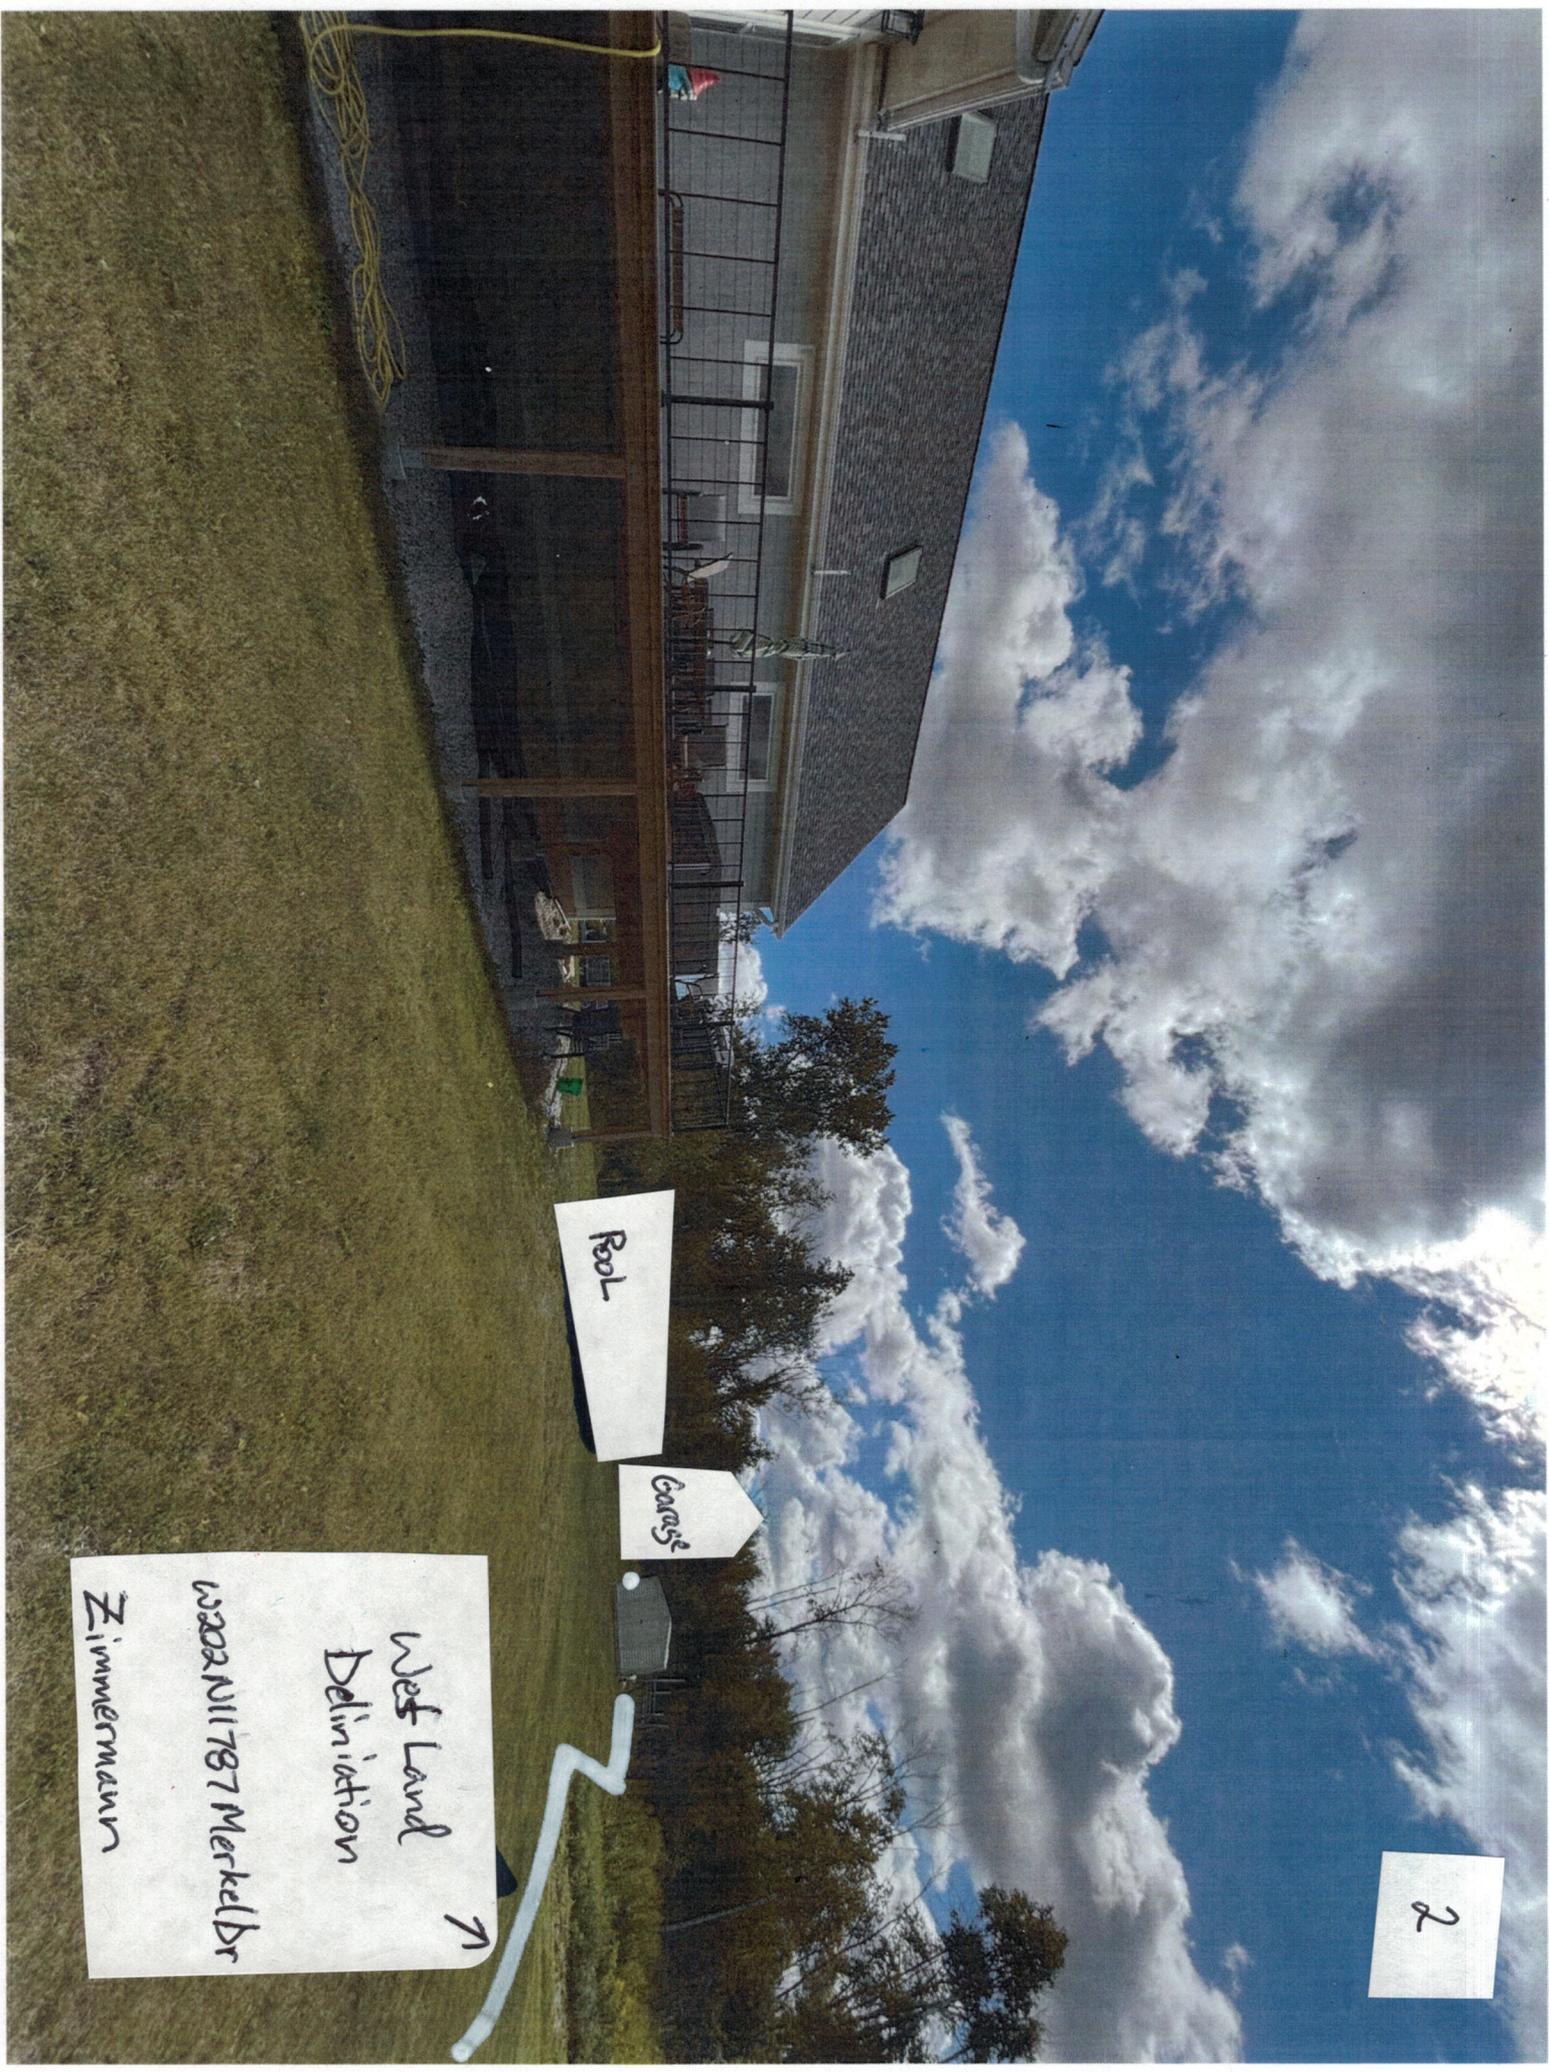
Pool to line up
with edge or plain
of existing deck

↑
WET LAND
DELIMITATION
